THE GREAT ALASKA EARTHQUAKE

Volume II

Illustrations and Maps

TECHNICAL REPORT NO. AFWL-TR-65-92, Vol II

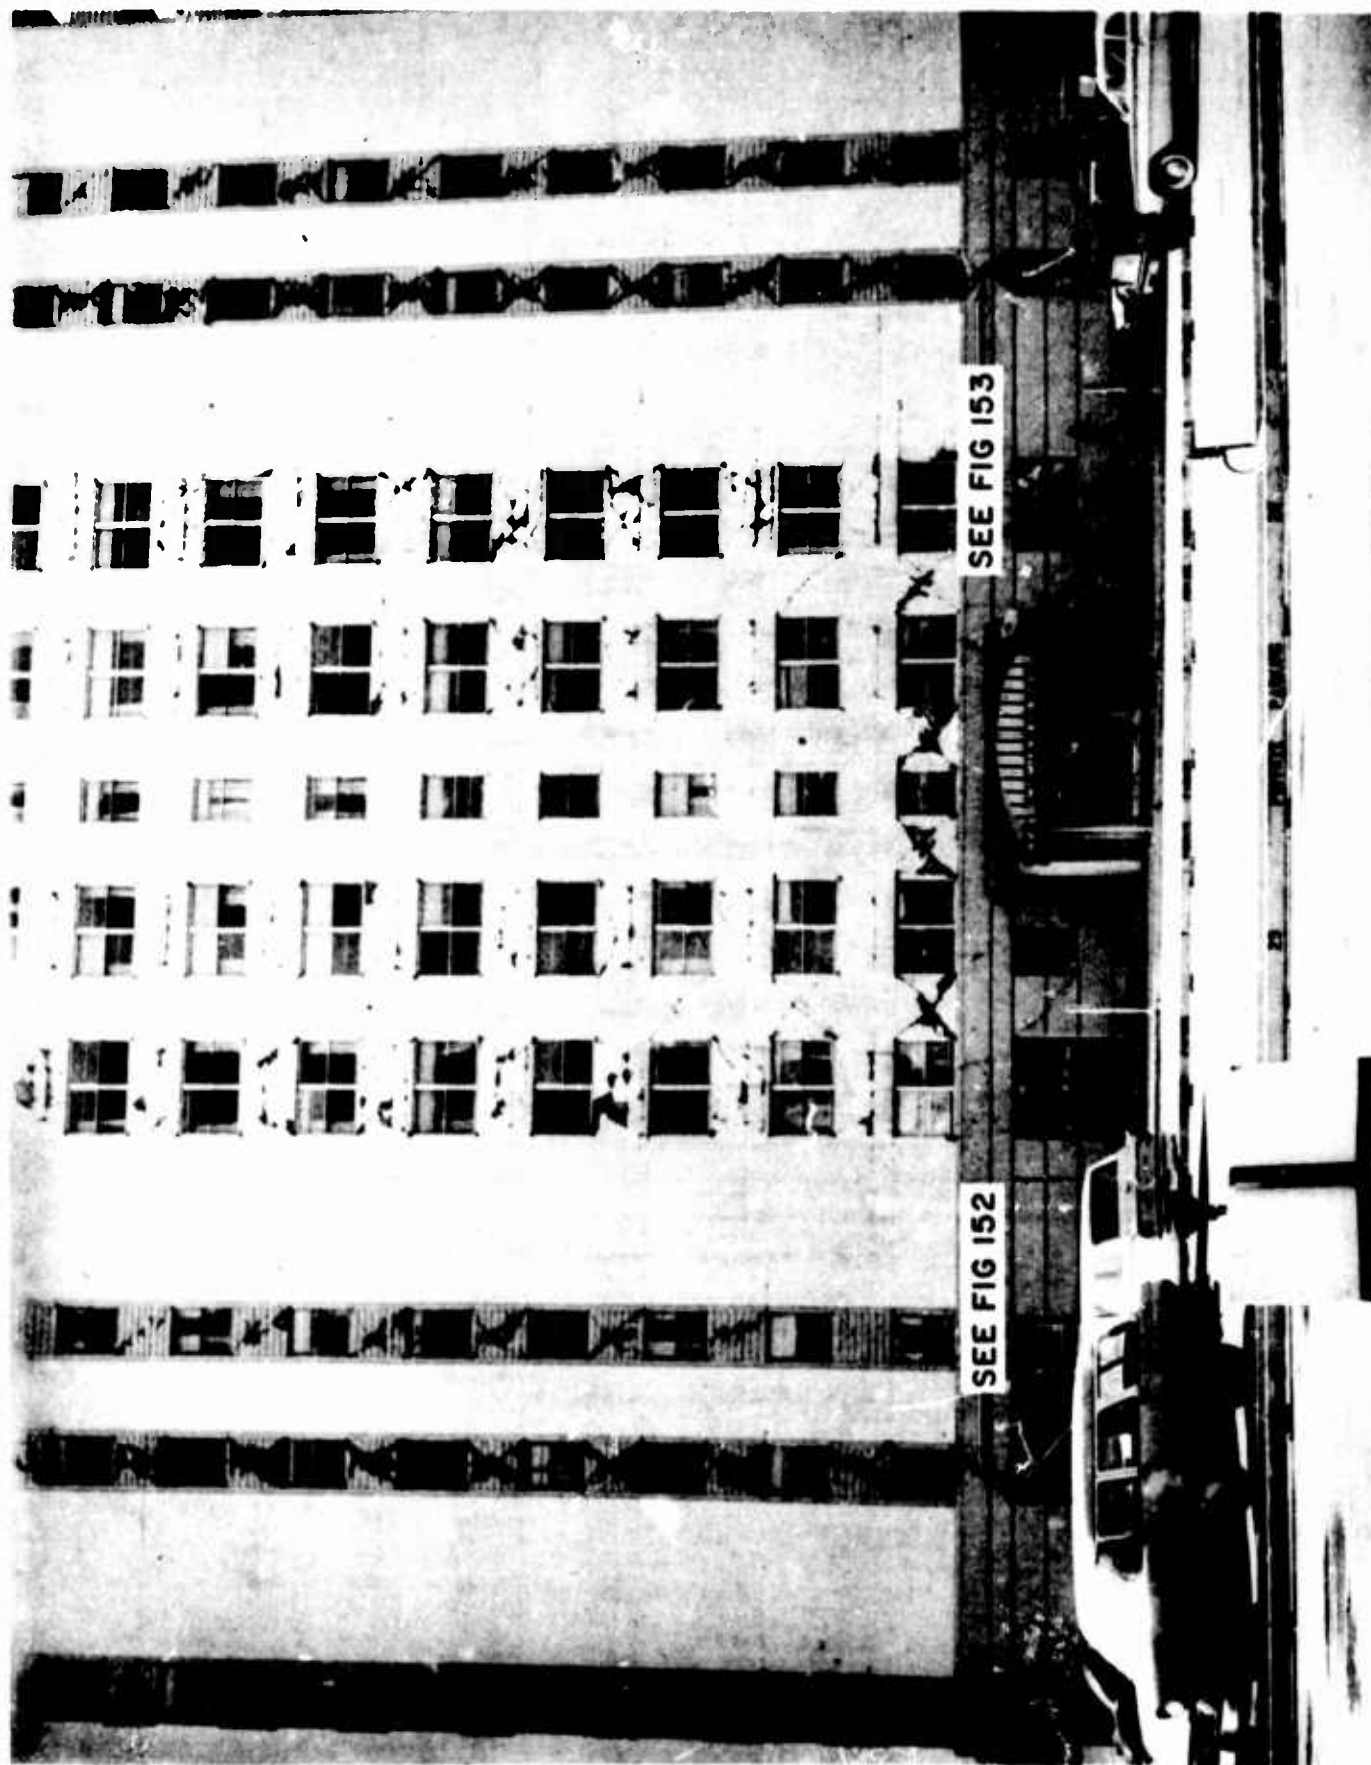
Figure 151. Mount McKinley Building
(East wall of structure showing major diagonal tension failures of second-floor level)

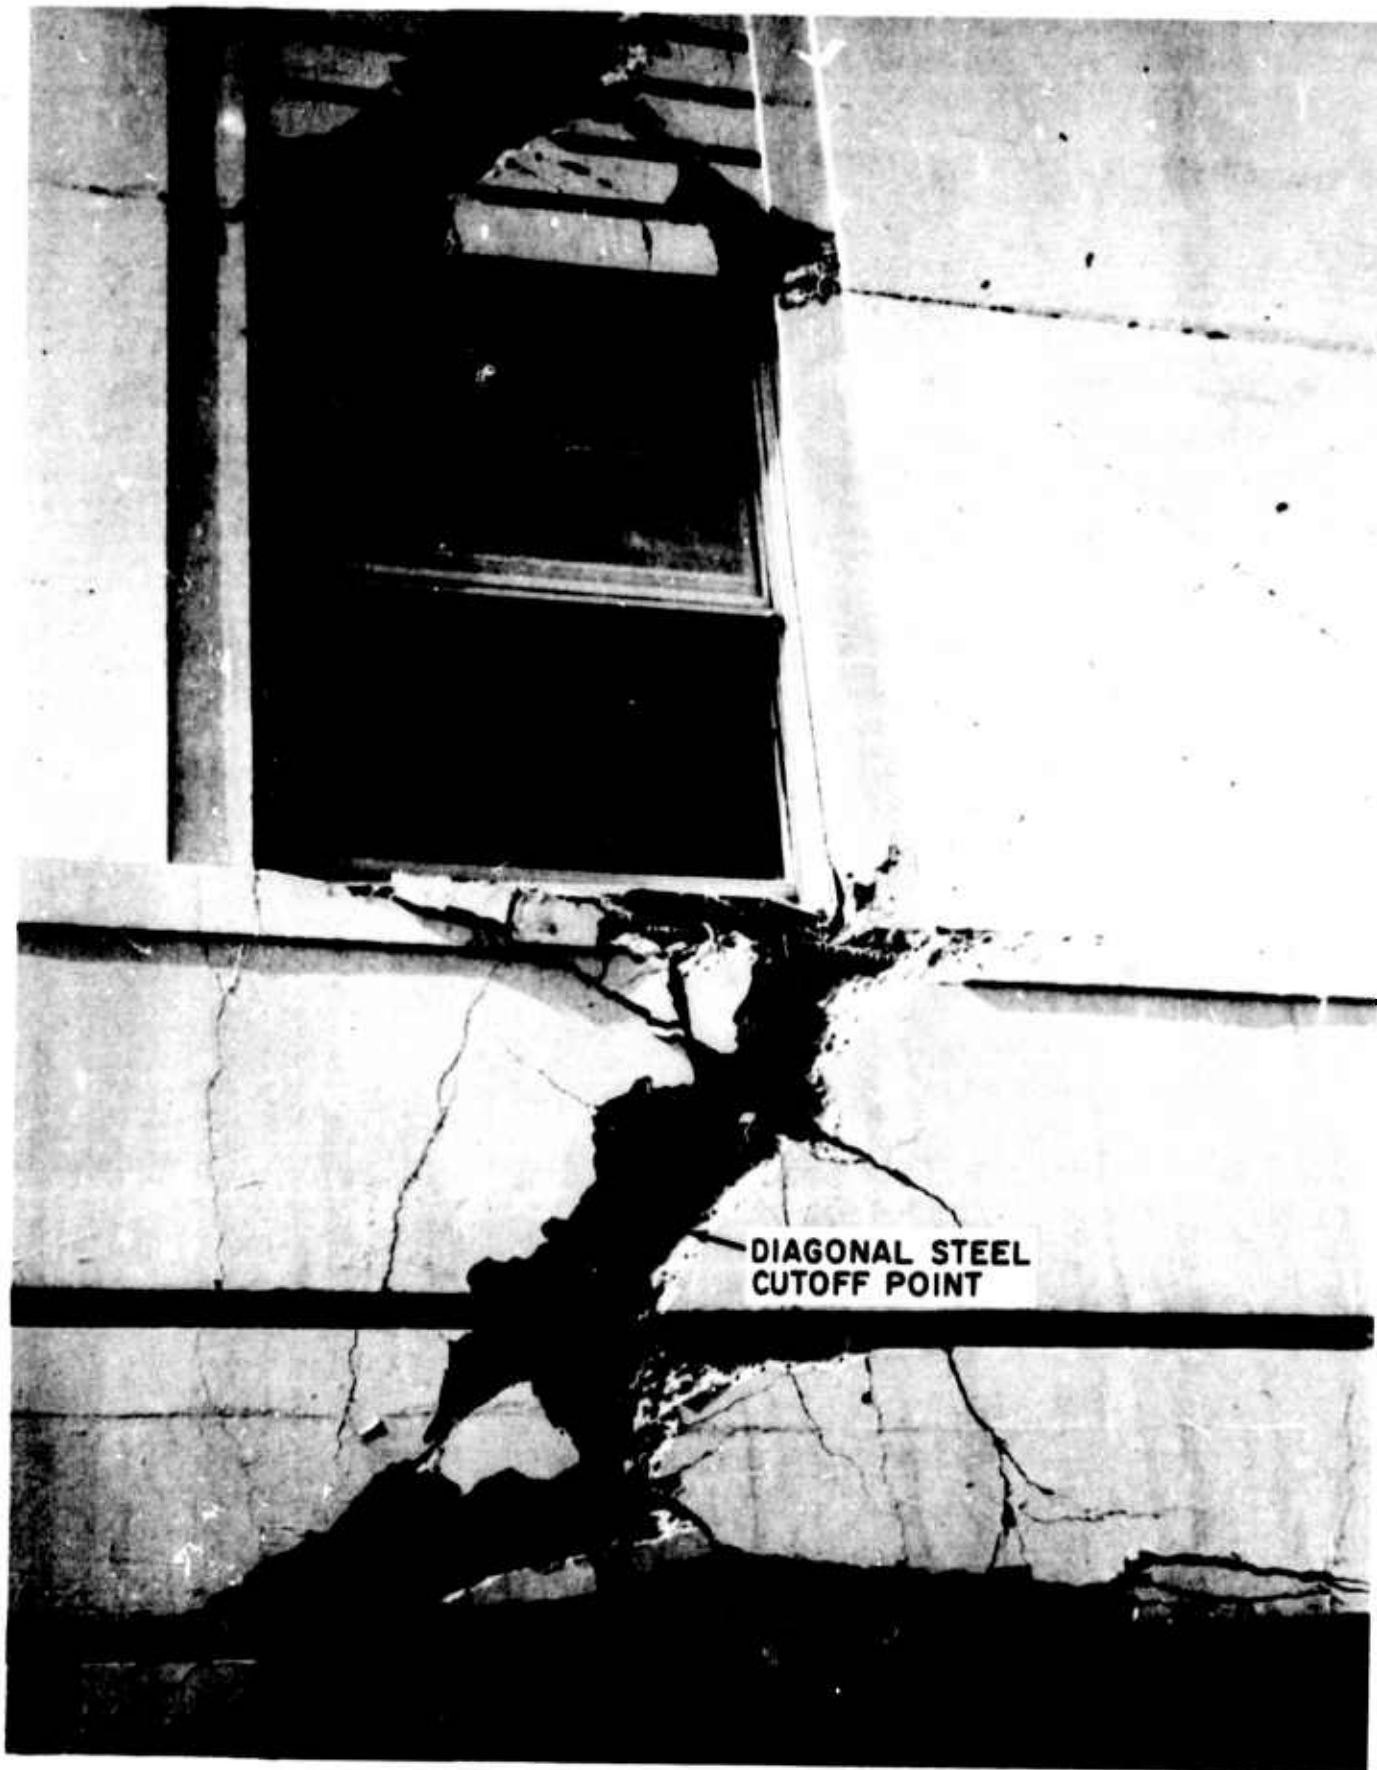
Figure 152. Mount McKinley Building
(Diagonal tension failure in east wall at second-floor level)

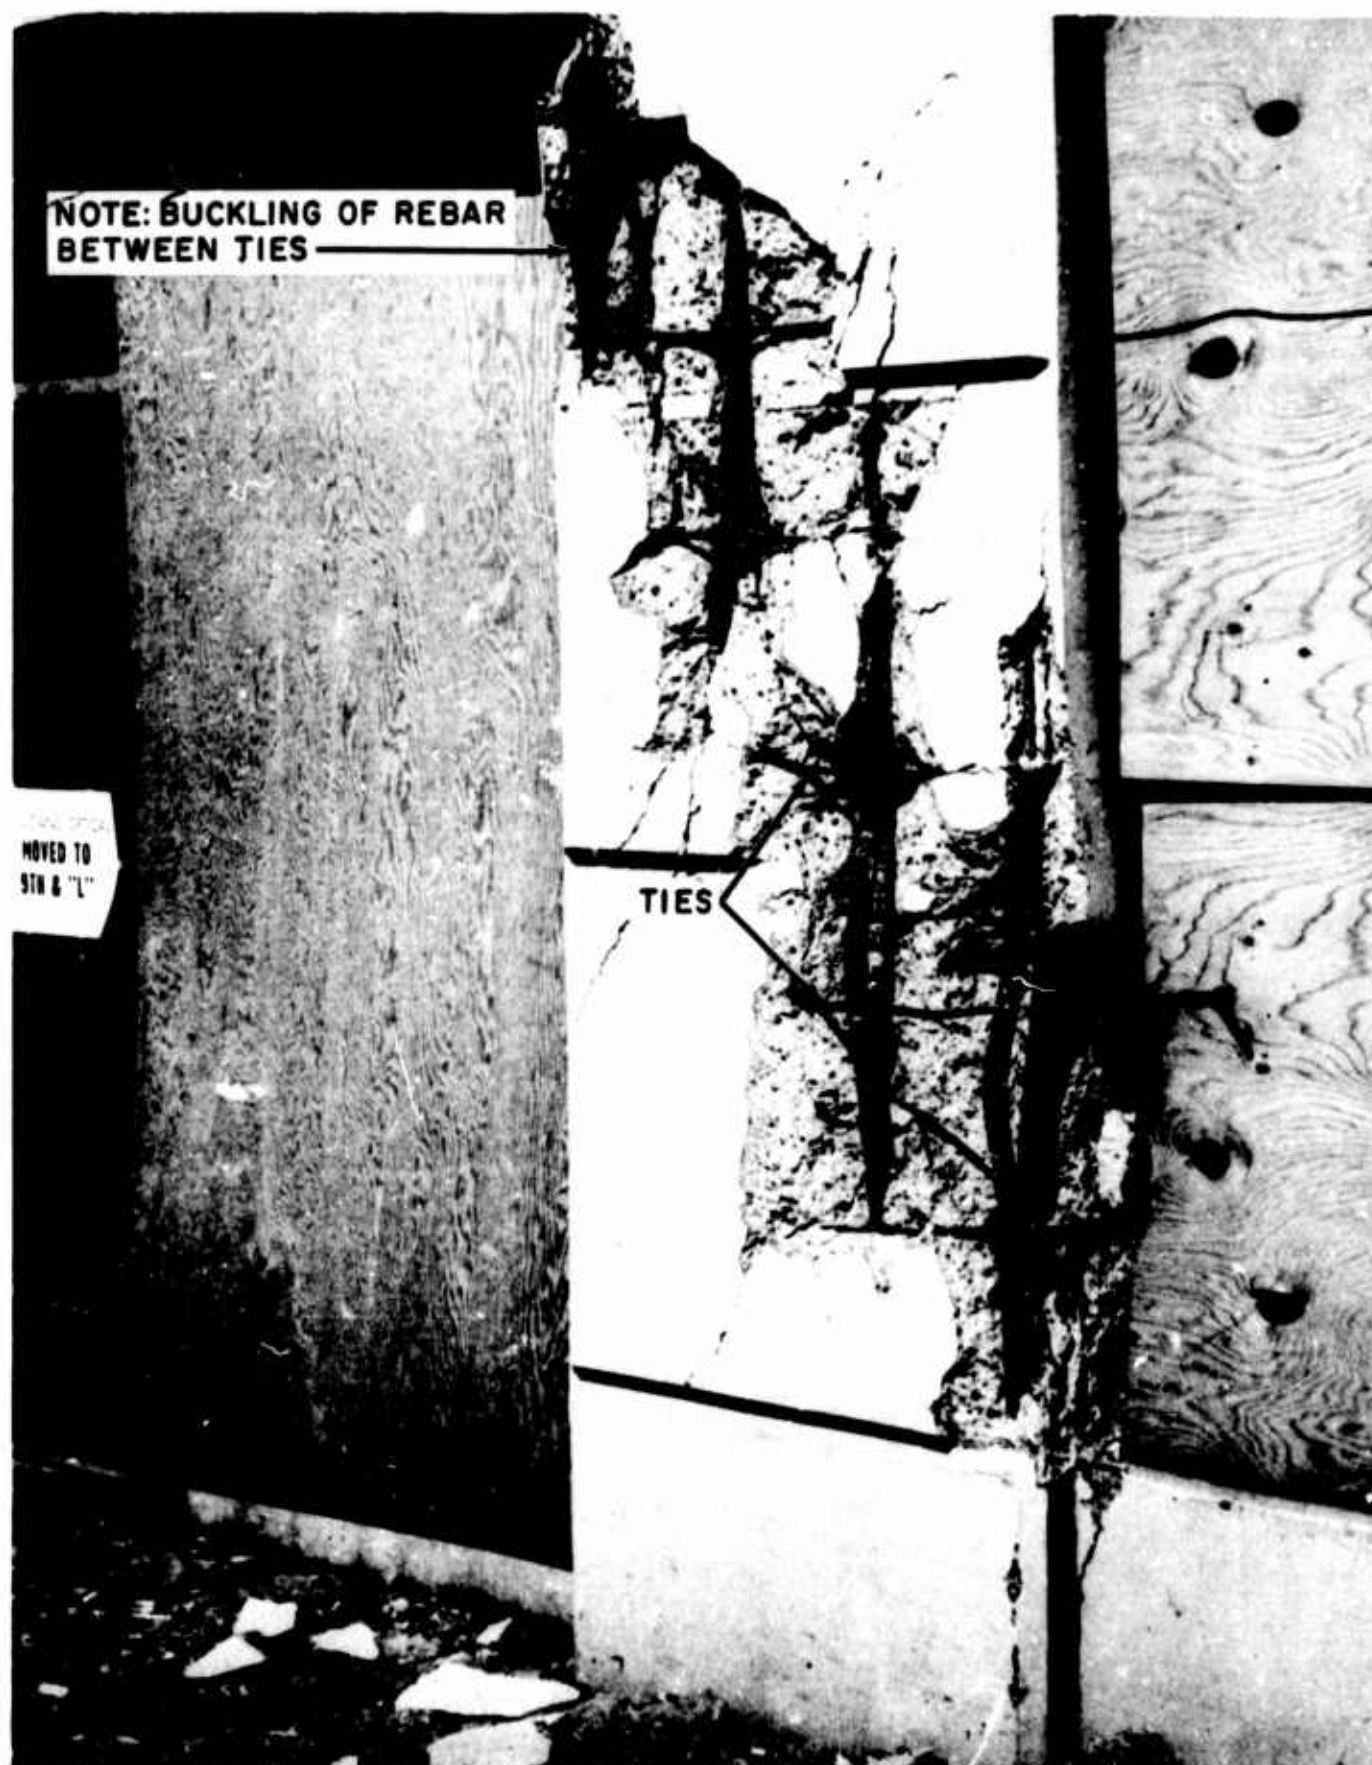
Figure 155. Mount McKinley Building (Shortened column in south wall near southeast corner of structure)

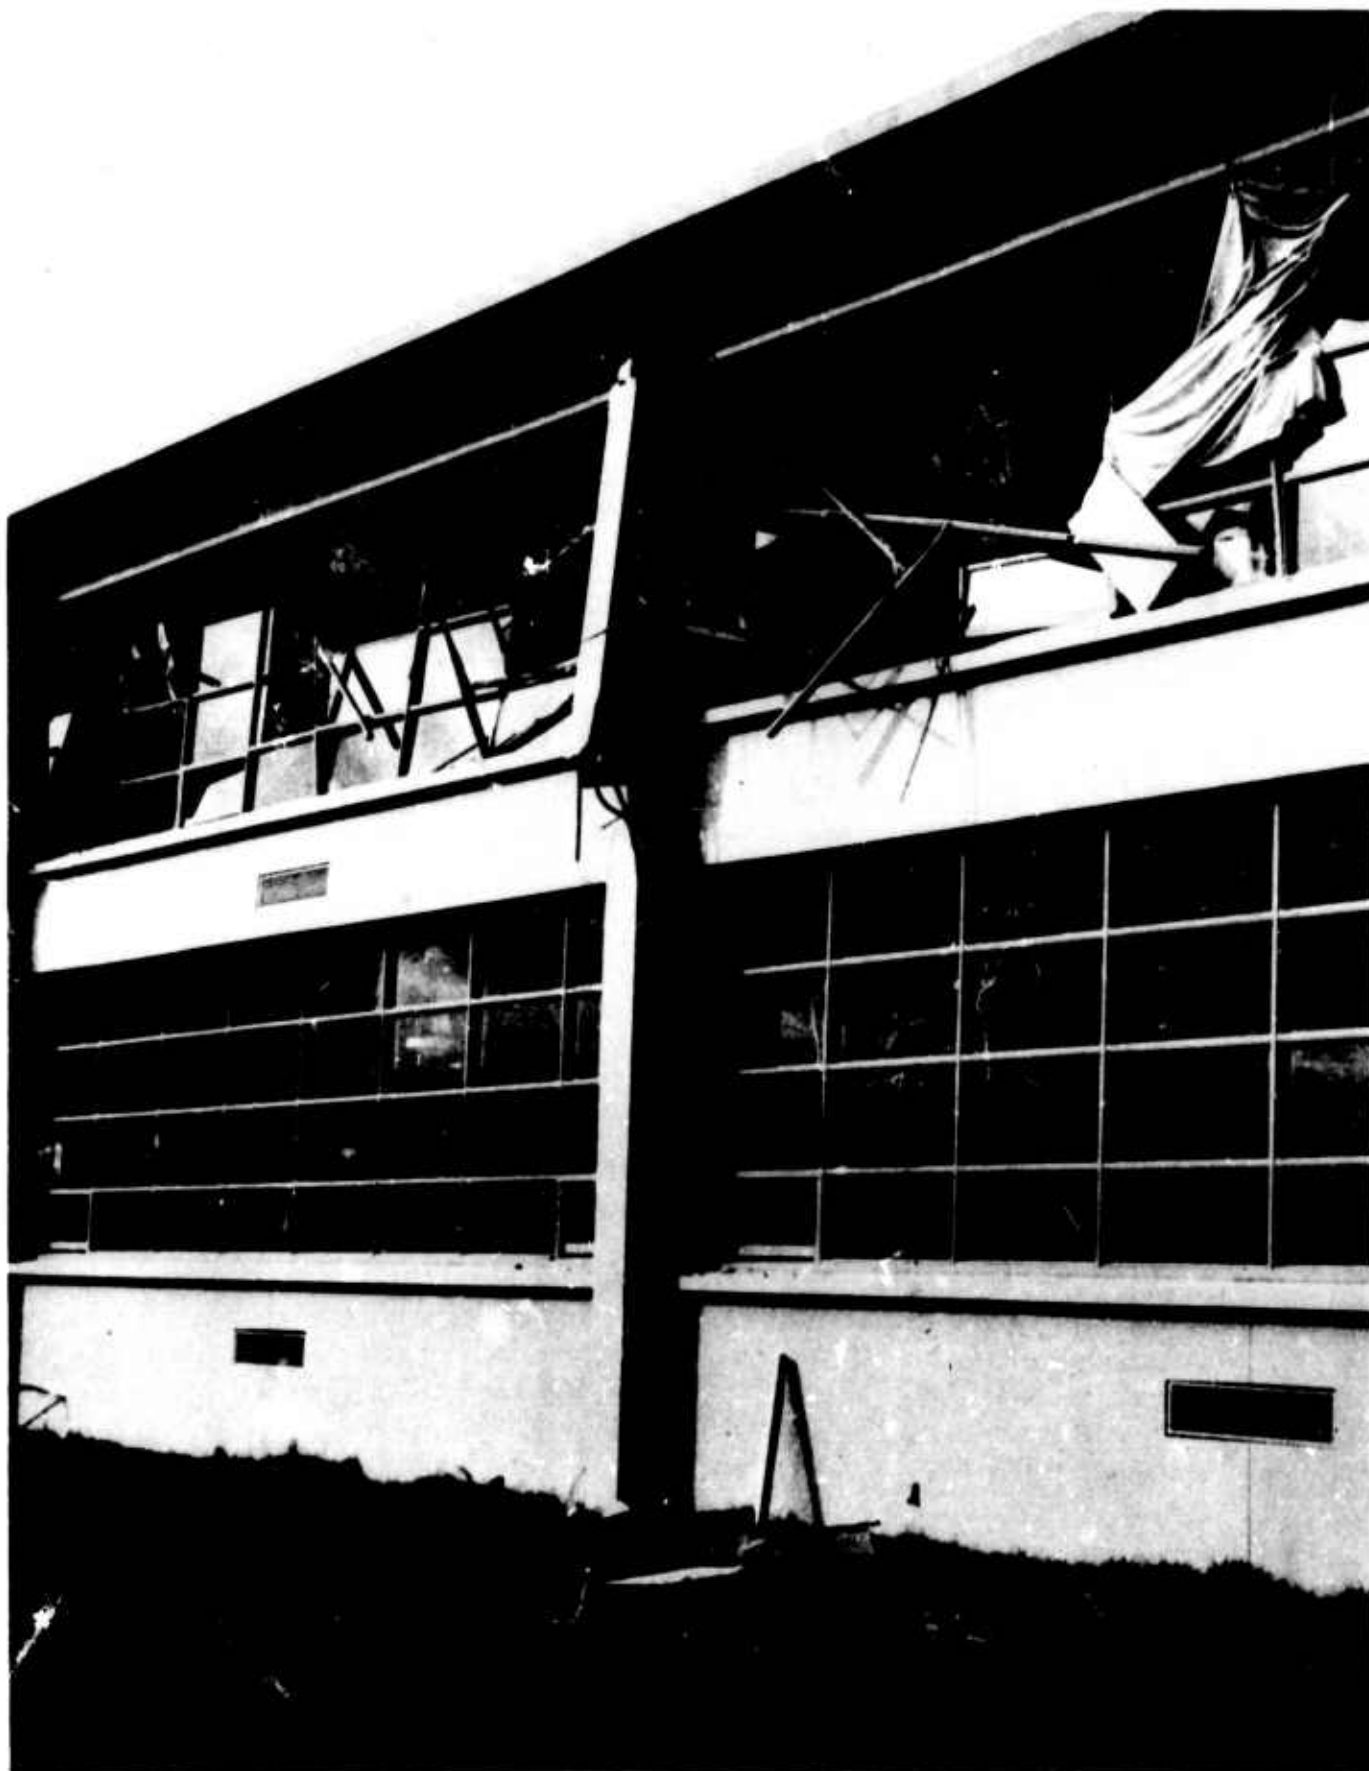
Figure 159. West Anchorage High School
(Damage to wing B and intersection of wings A and B)

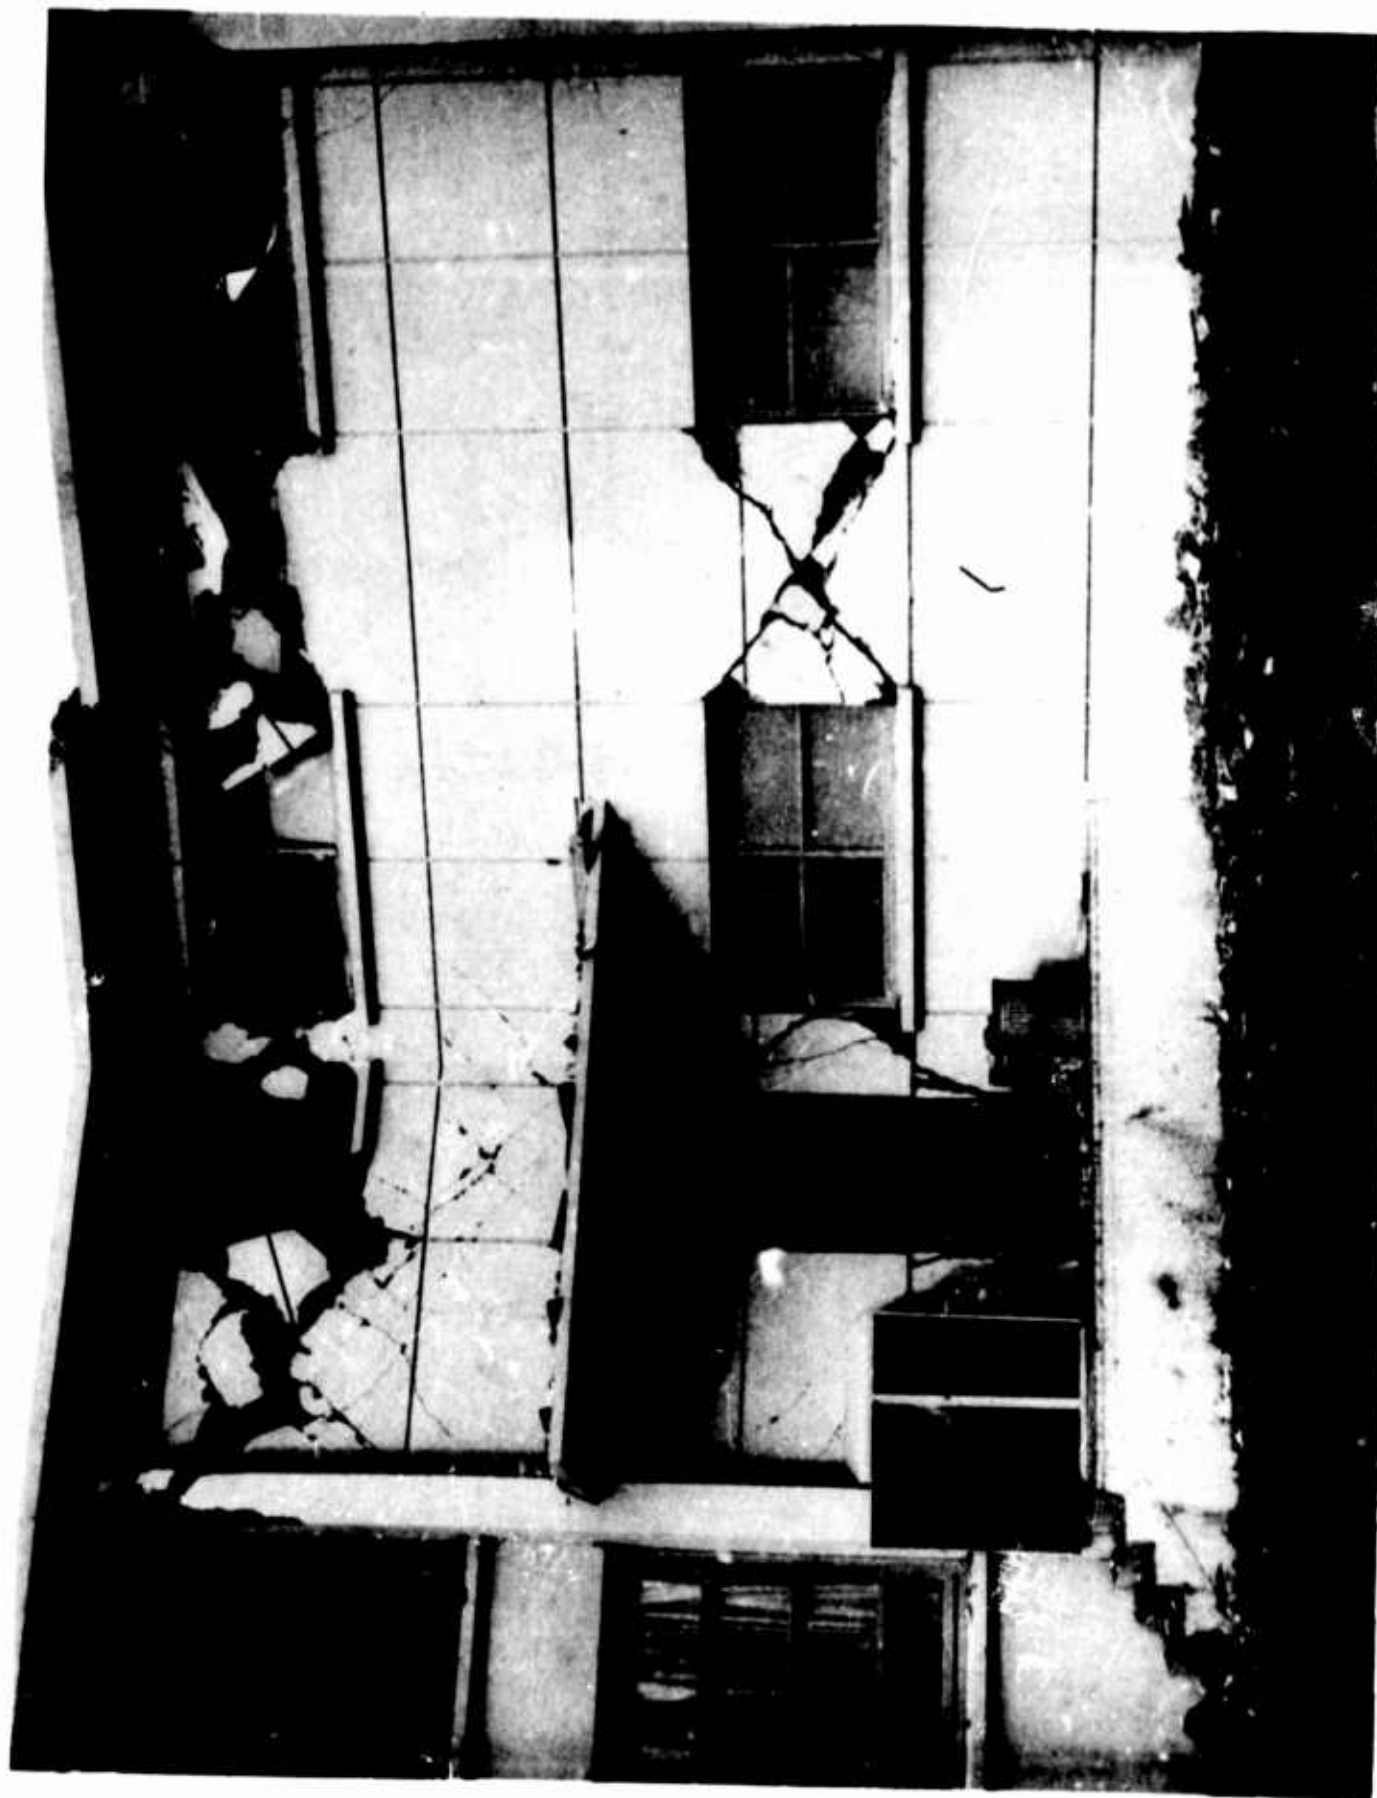
Figure 162. West Anchorage High School (Damage at intersection of wings A and B)

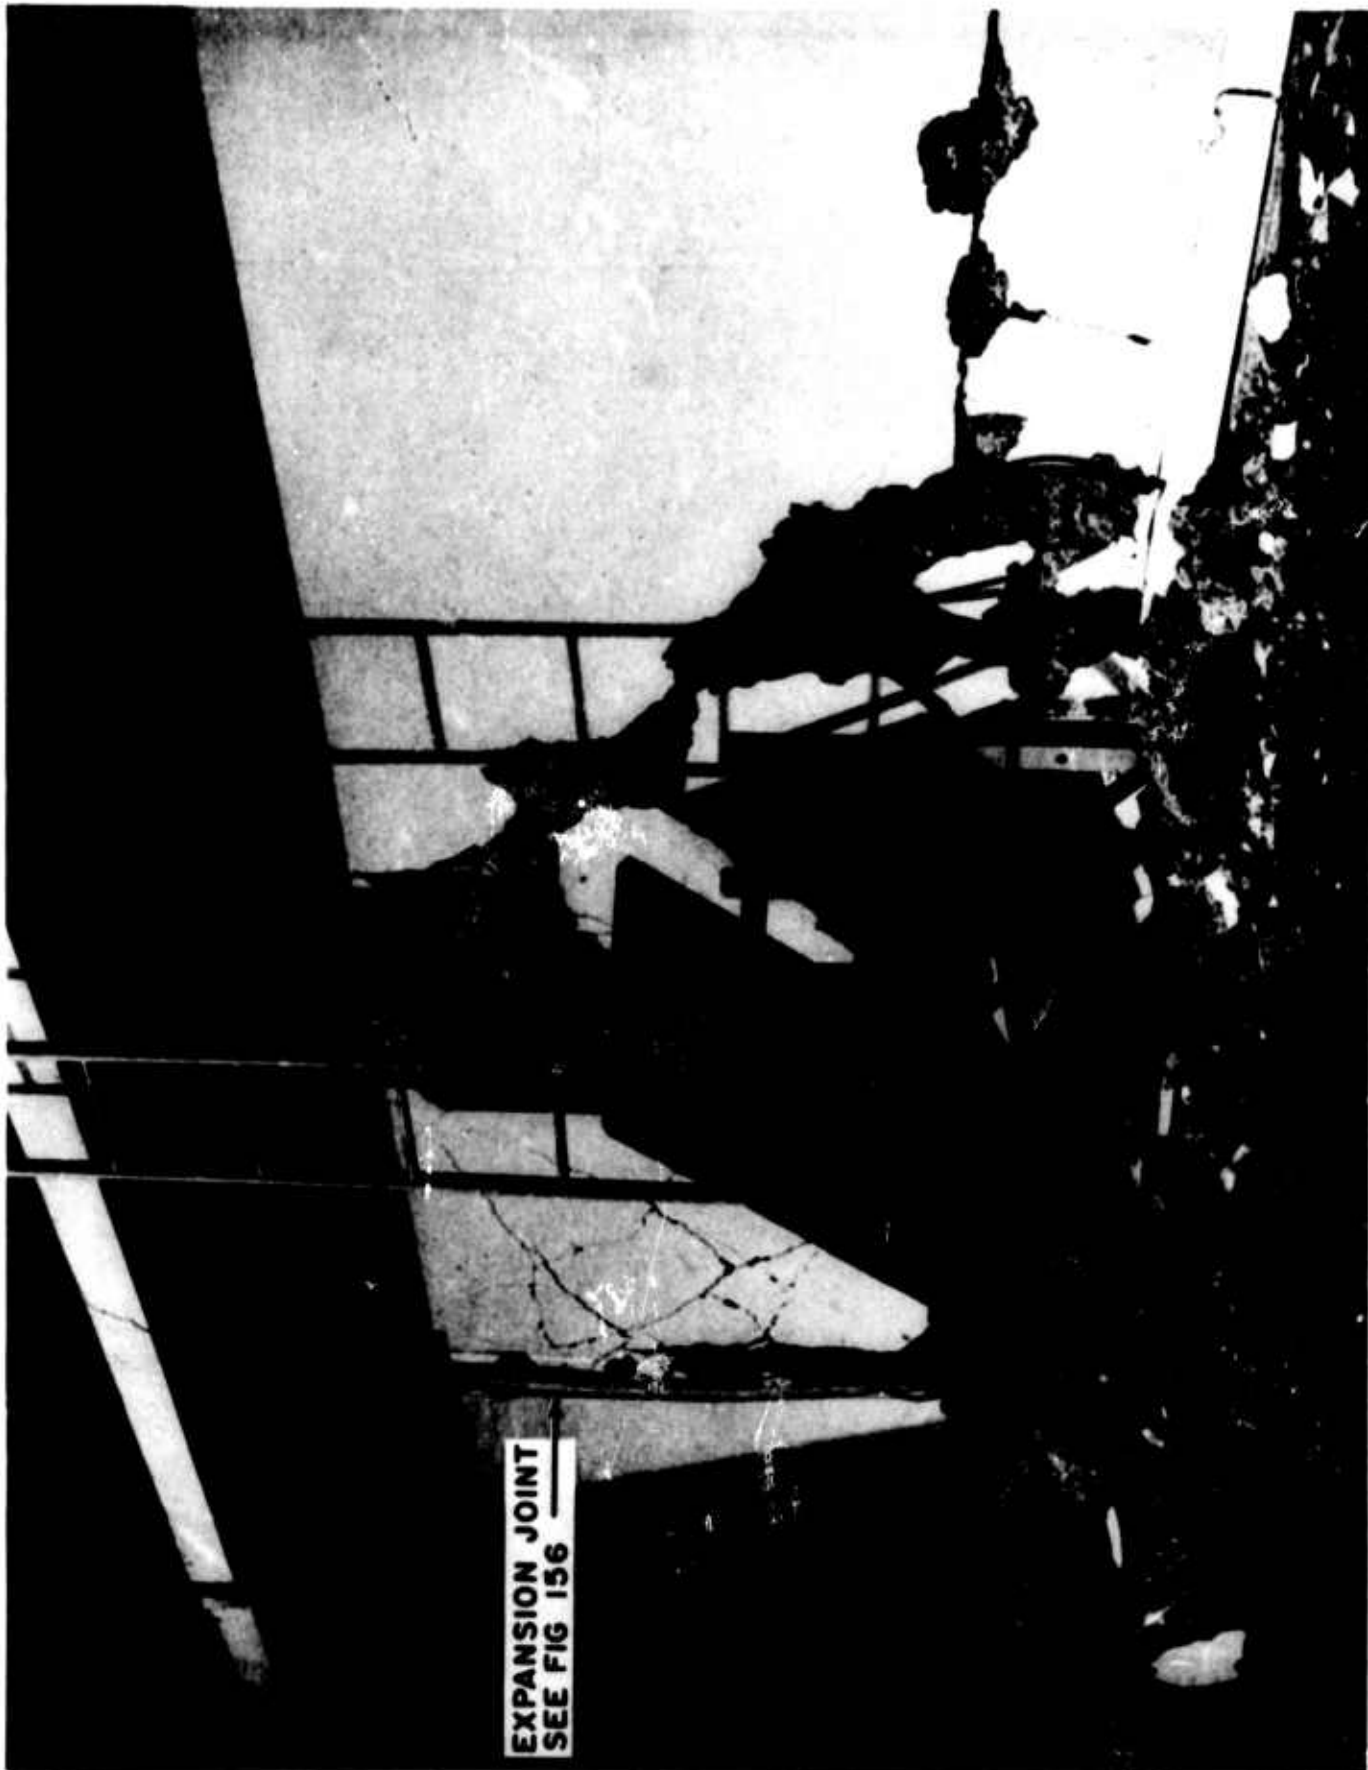
Figure 163. West Anchorage High School (Damage to wing B near expansion joint between wing B and auditorium/gymnasium structure)

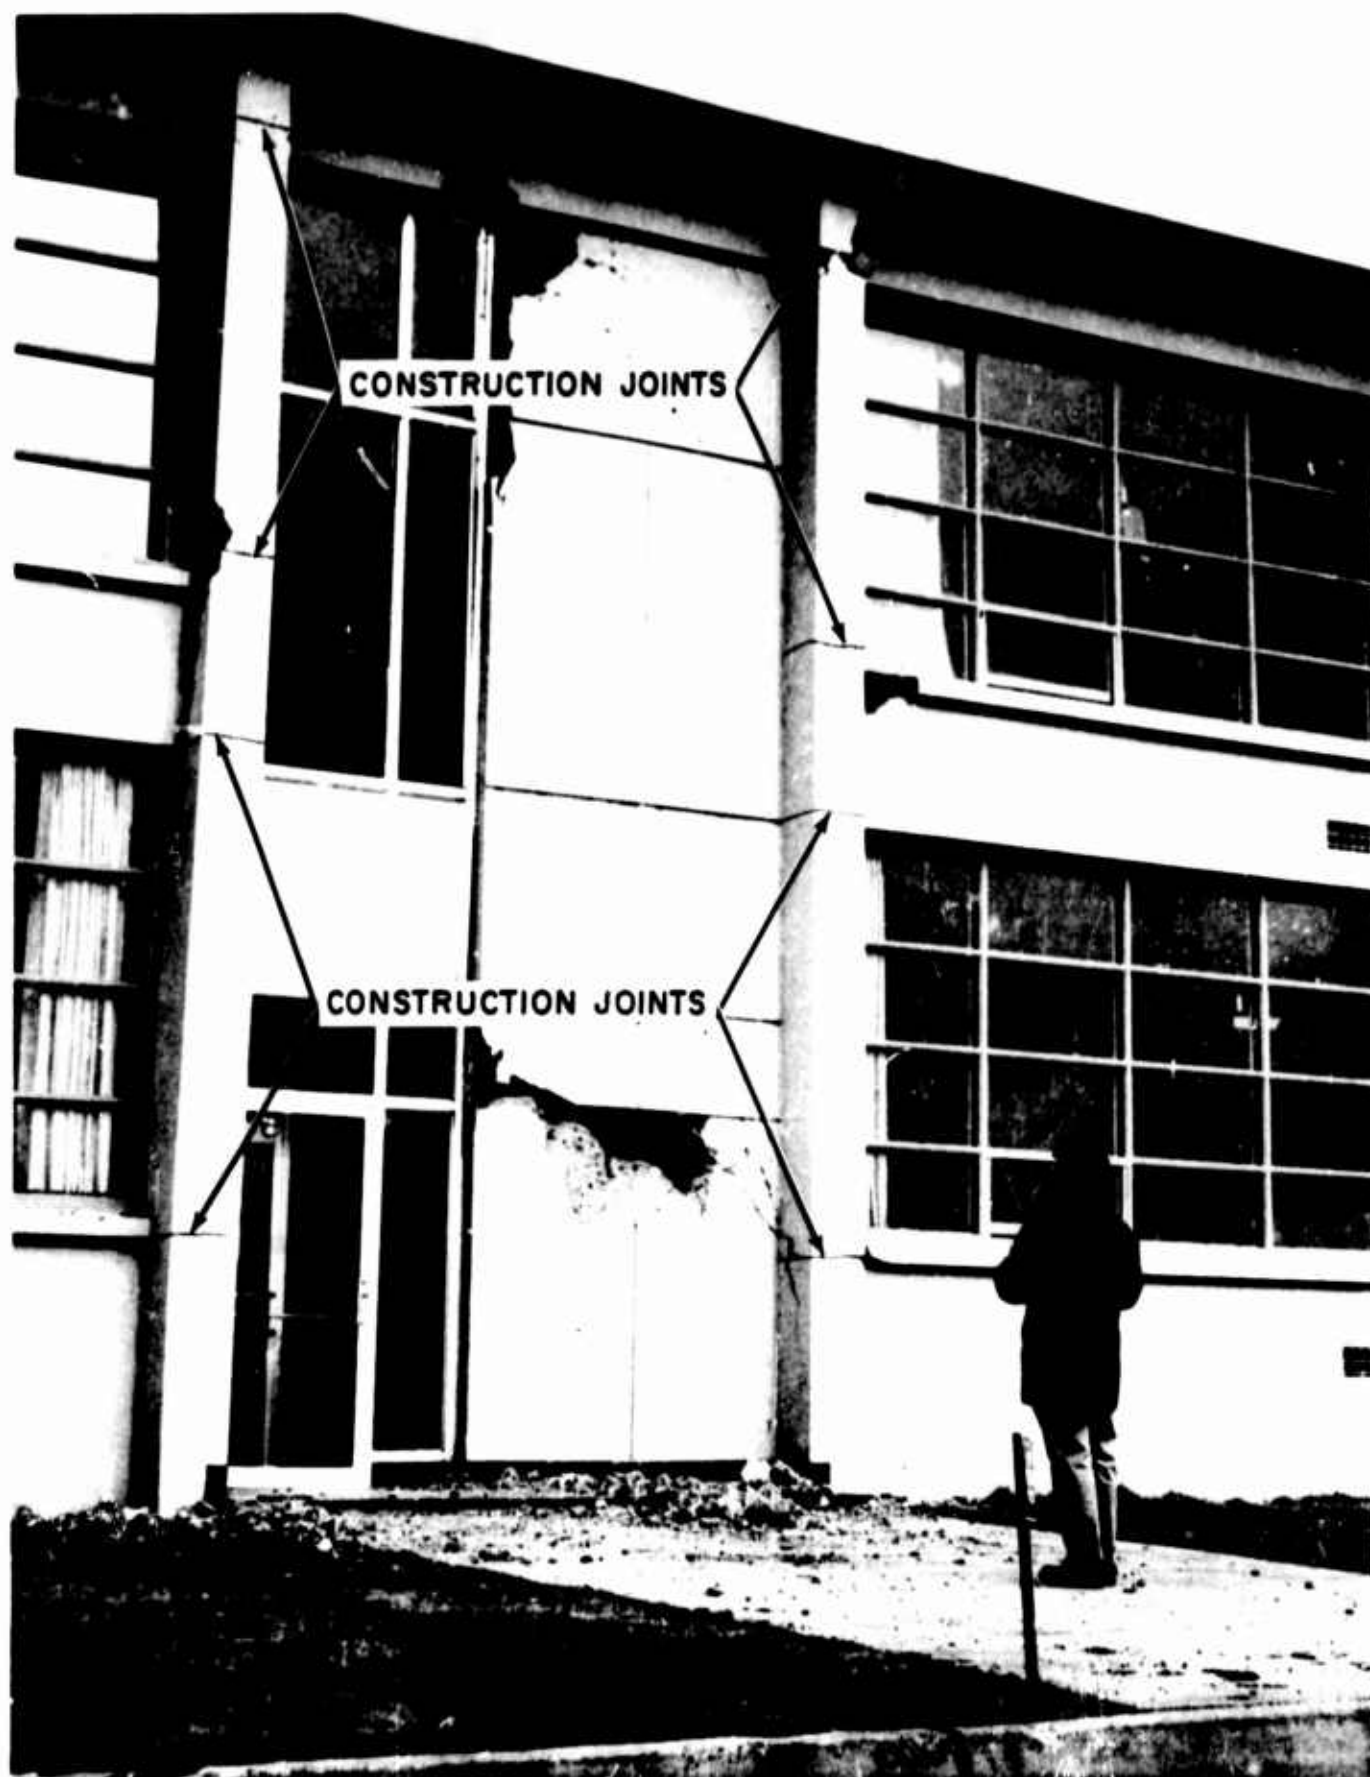
Figure 170. West Anchorage High School
(Damage to wing A addition near expansion joint
between addition and original wing A)

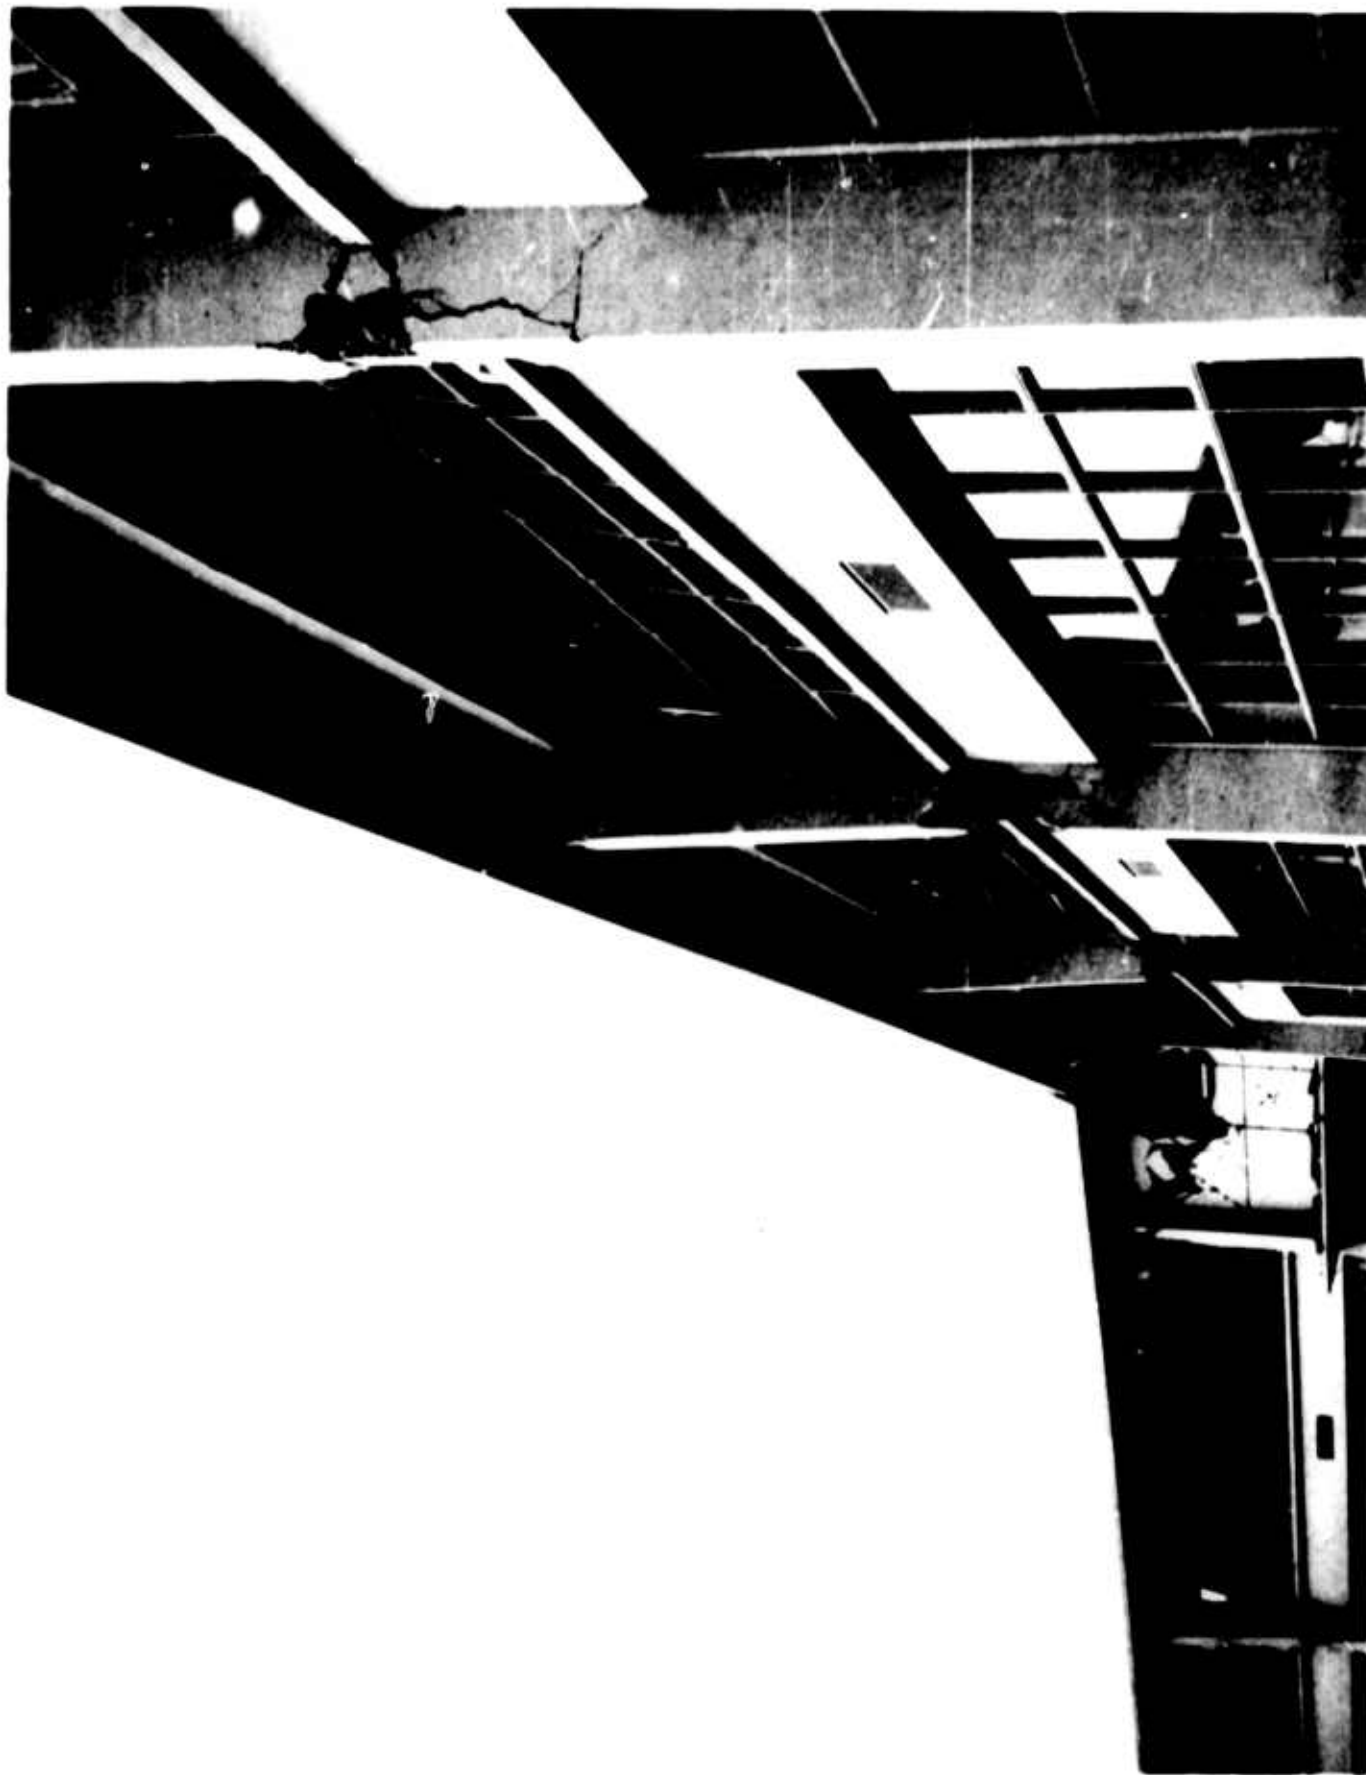
Figure 174. West Anchorage High School (Damage to second-story columns in west wall of wing A near intersection of wings A and B showing consistently poor column construction joints)

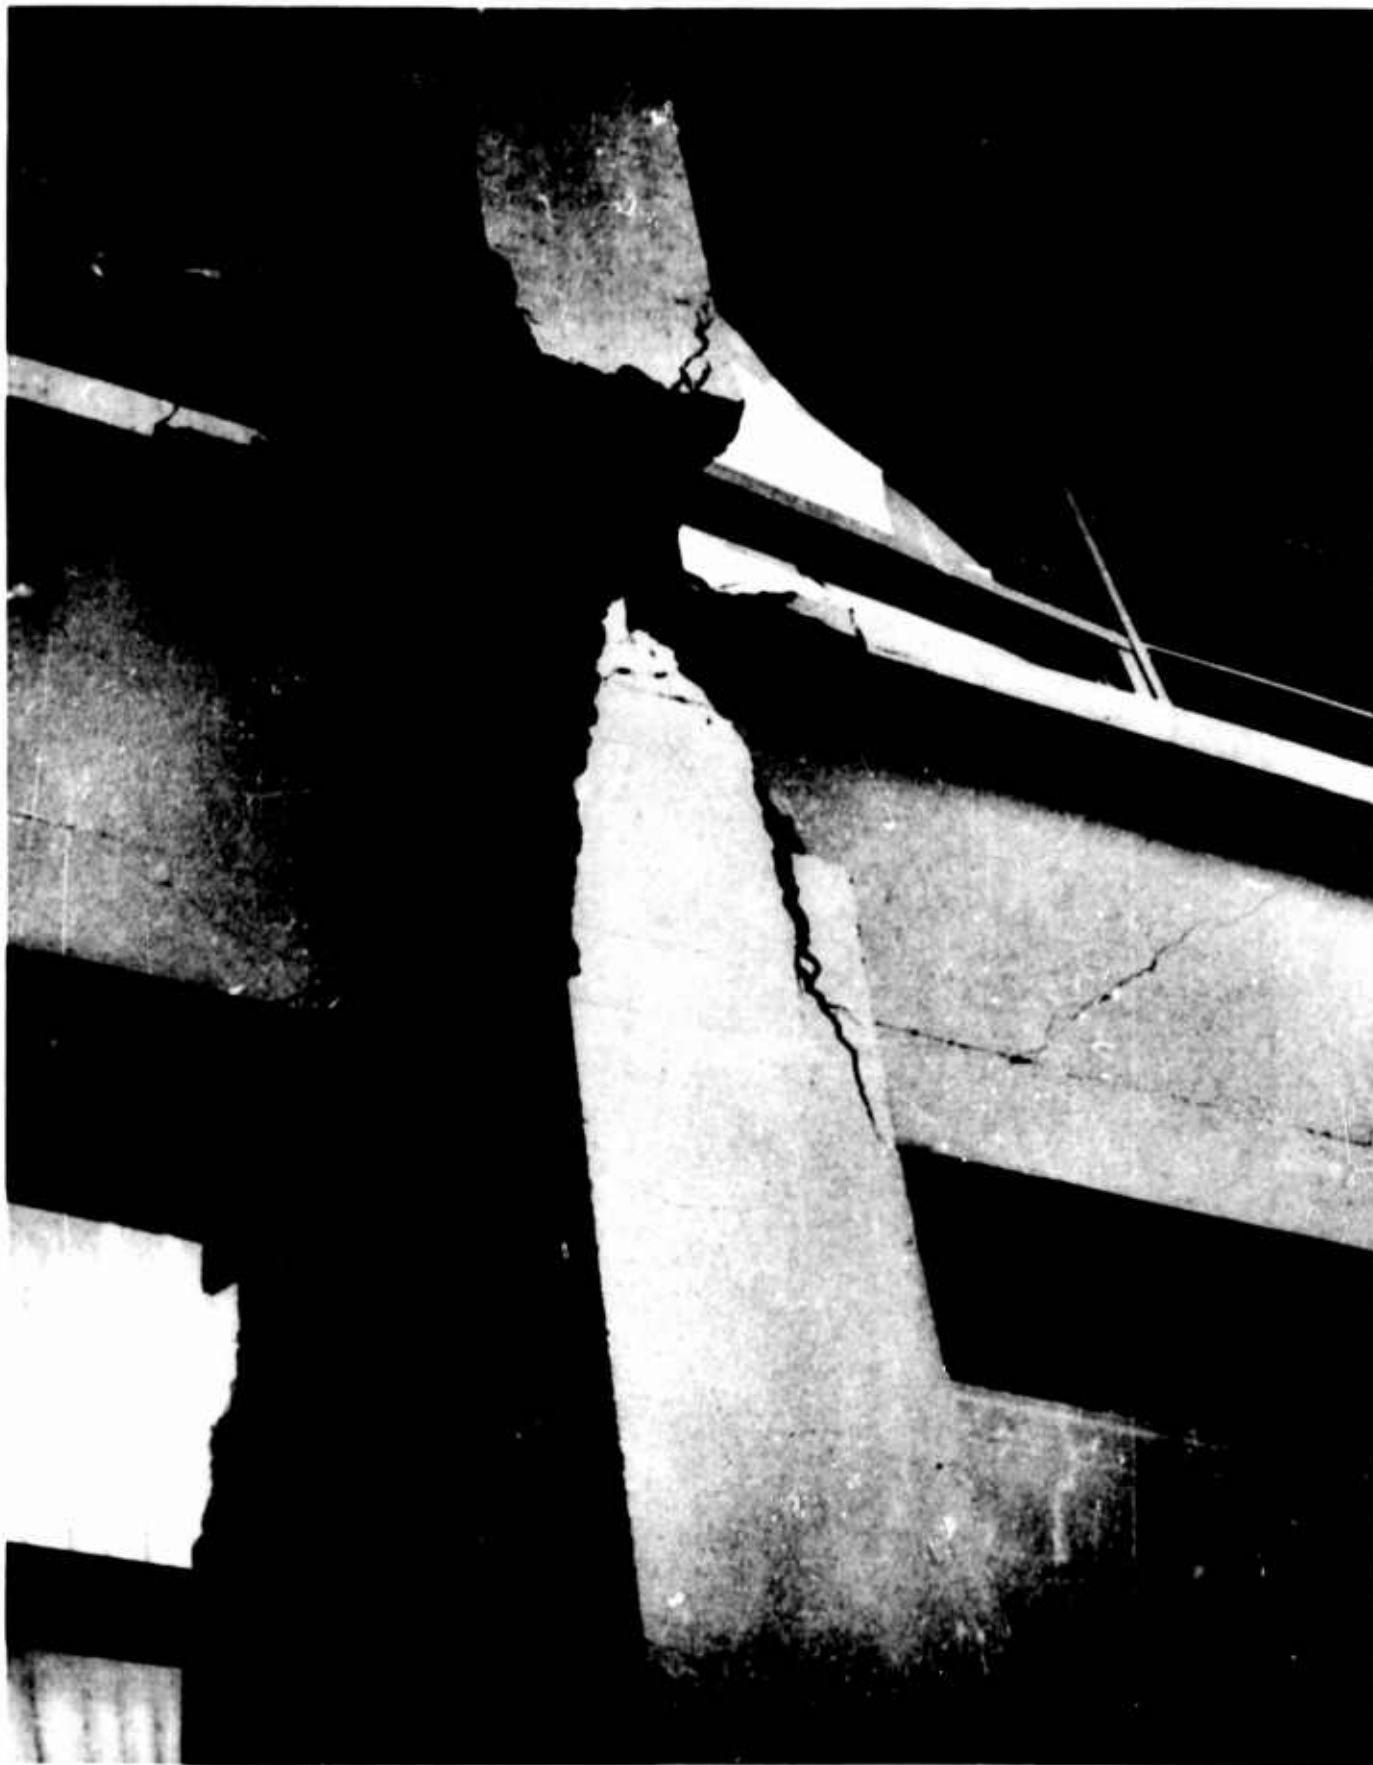
Figure 175. West Anchorage High School
(Closeup of damaged column shown in figure 174)
